Structural Assessment: Existing & Work To Do

Structural Review - Lakewood Theater

Date: June 28, 2010

Project Name: Lakewood Theater Review - Lakewood, Washington
FCE Project #: 10-T229

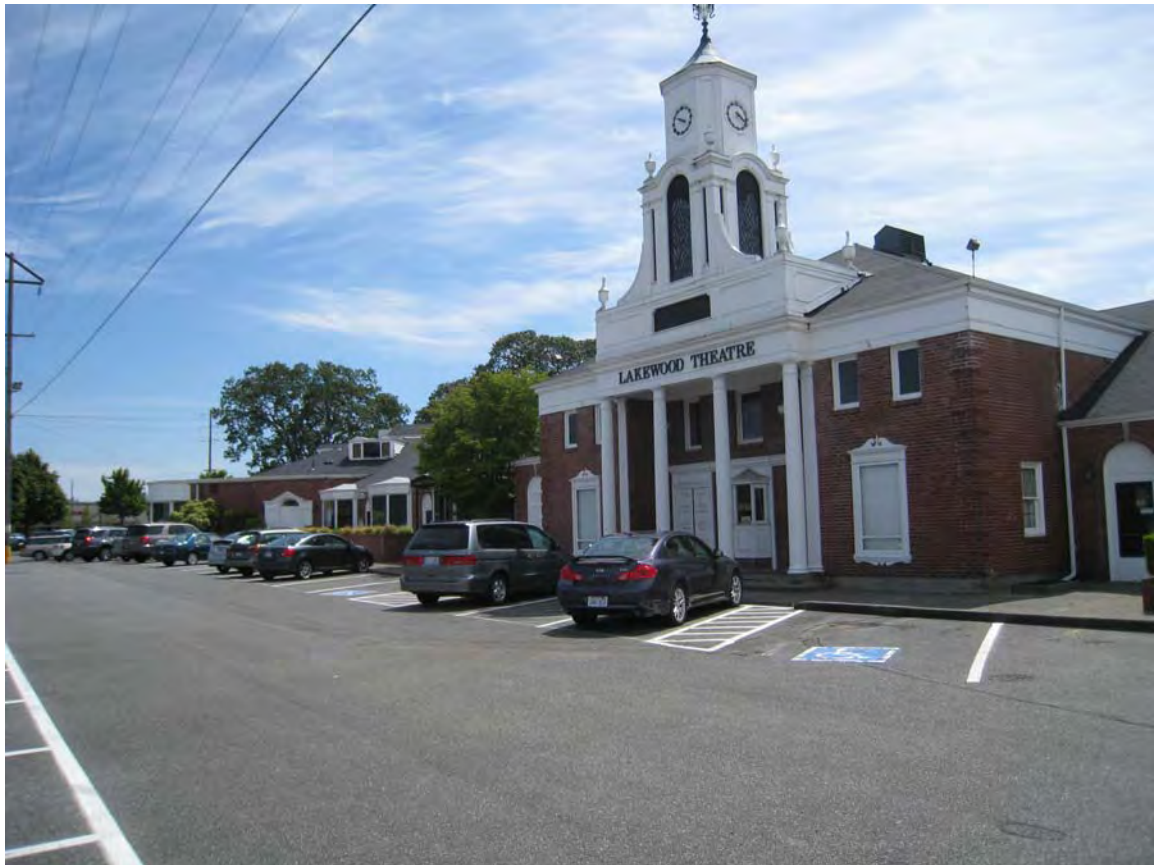
Photo #1: Main Front entry of Theater

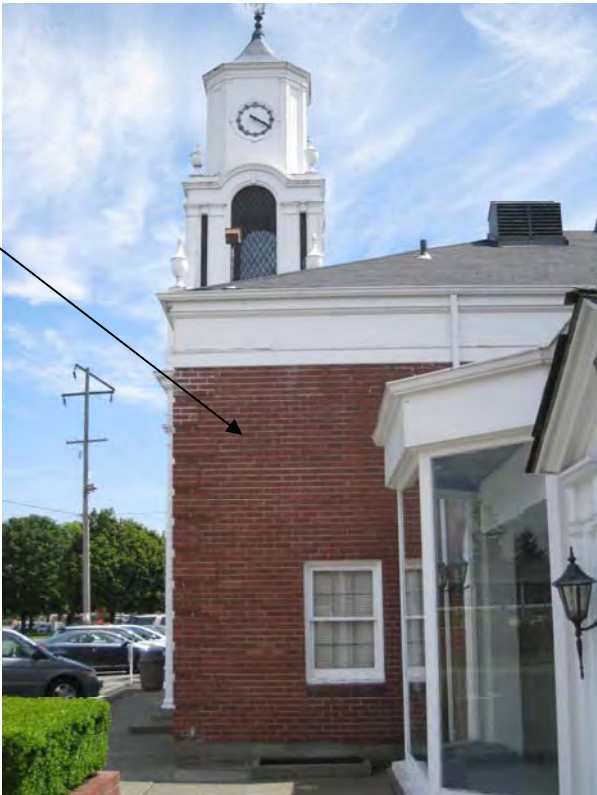
- Veneer in good condition throughout the exterior, no stud deterioration.

Photo #2 – Brick veneer typical throughout exterior

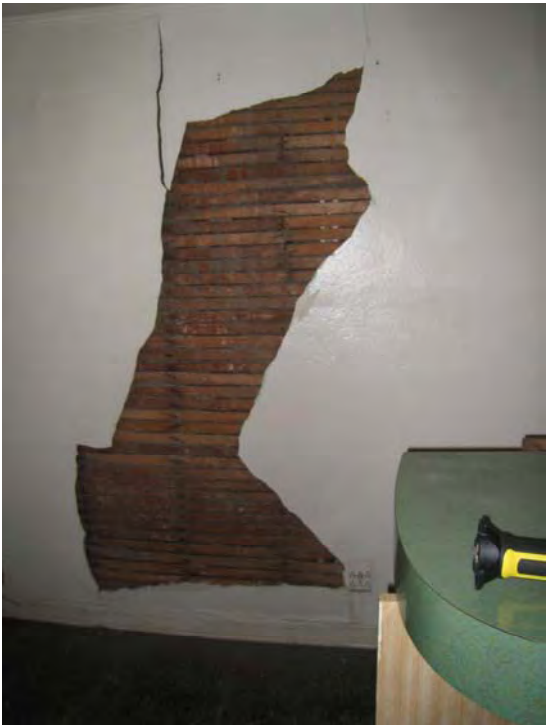
- Horizontal lateral forces are resisted by interior and exterior walls. The exterior walls have a combination of exterior horizontal 1x8 T&G sheathing and interior wood lath and plaster. Codes allow for a reasonable shear load capacity for this assembly.

Photo #3 – Lathe & Plaster at interior face of wall

Recommendation: Where possible, add 1/2" plywood to all exposed studs to increase shear capacity. A seismic analysis will show where new holddown anchors would be required. Provide epoxy anchors to connect the sill plates to the concrete walls. In some areas, it may be necessary to remove existing finishes or overlay existing finishes with plywood – depending on the level of seismic upgrade that is established by the re-development plans.

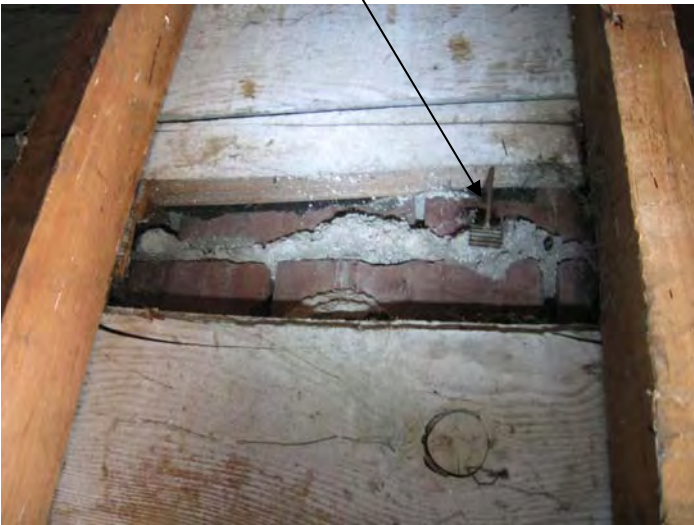
- Perimeter wood framed walls with horizontal 1x8 T&G sheathing with 4" thick brick veneer. Interior walls will also contribute seismic resistance with the lath and plaster sheathing. Presence of veneer ties was detected. It appeared the veneer was placed directly against the 1x8 wall sheathing, possibly bonded with the grout/mortar.

Photo #4 – 1x8 T&G exterior sheathing with brick veneer and evidence of masonry ties

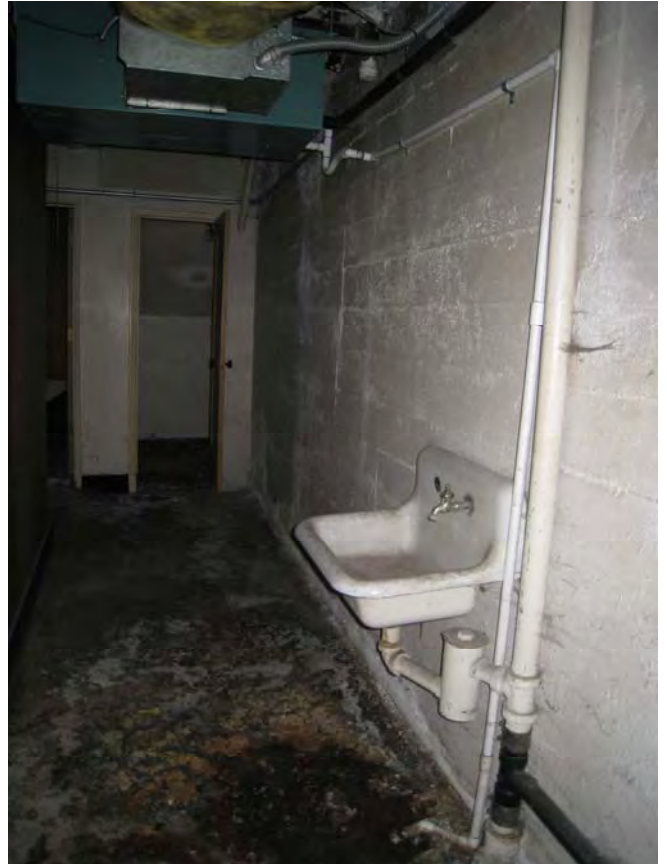
- Very few cracks or signs of efflorescence seen in basement retaining walls, good condition.

Photo #5 – cast-in-place concrete basement walls throughout

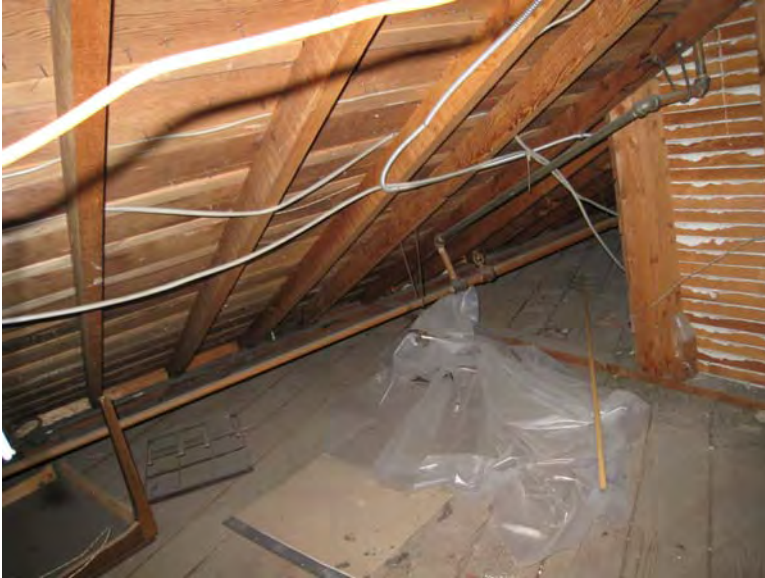
- The roof diaphragm consists of horizontal 1x8 T&G decking. Codes allow for a limited seismic resistance for this type assembly.

Photo #6 – 1x8 T&G roof sheathing over 2x4 roof joists/rafter

Recommendation: It appears the existing asphalt shingle roof is fairly new. Perform a full roof tear-off and add 1/2" plywood on top of the T&G throughout the entire roof at next re-roofing. This will substantially increase the diaphragm capacity of the facility.

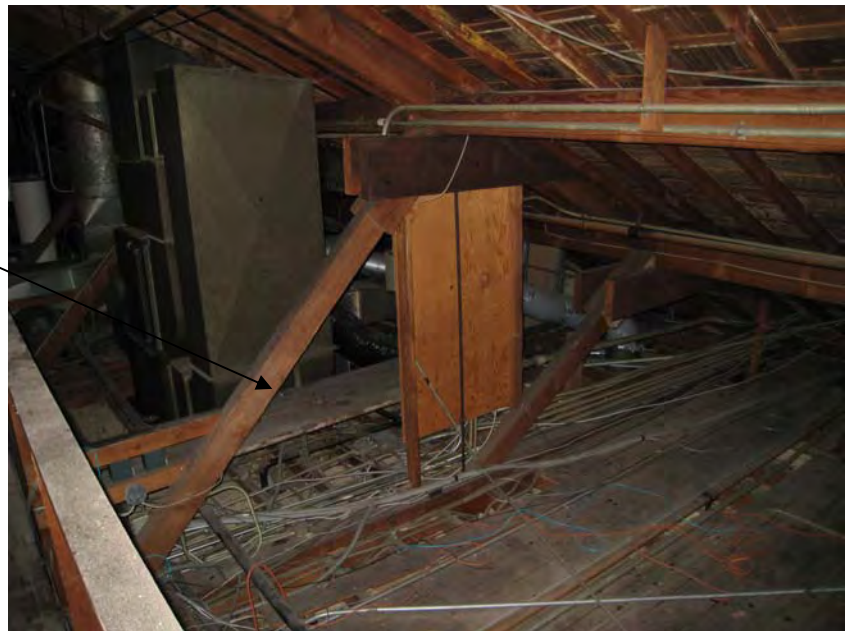
- No roof framing damage/deterioration detected in areas observed.

Photo #7 – Heavy timber built-up trusses at roof in some areas
